# Manhole Inspection Summary

Manhole # S41Y1\_026MH

Insp Date: **6/24/08 10:39 AM**

**Location** Address: **644 E. Patapsco Ave.**

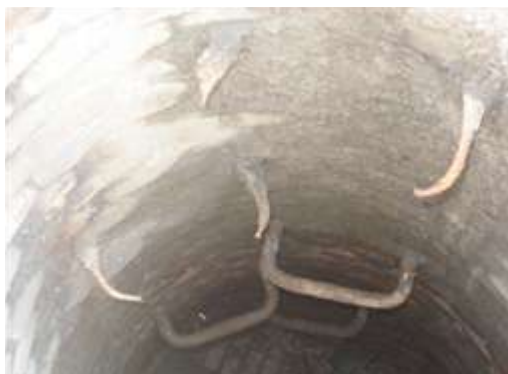
Steps

Count: **7** Missing: **2** ☒ Corroded

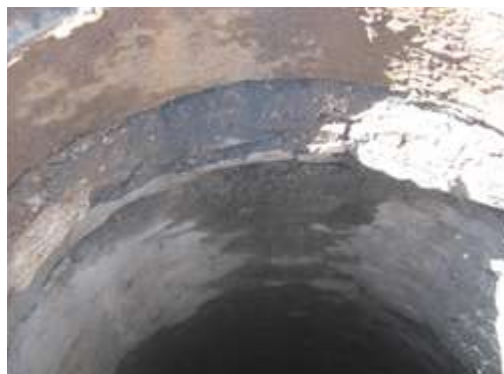
Defect 1

Offset: **2** (in.)

Frame offset

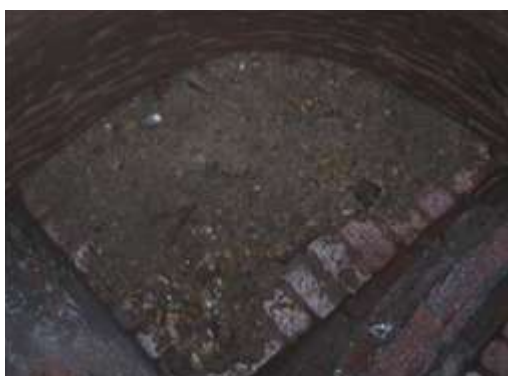
Defect 2

Condition: ☐ Sound ☐ Cracked ☐ Root Intrusion ☐ Deteriorated ☐ Leaks ☒ Debris

Debris on bench

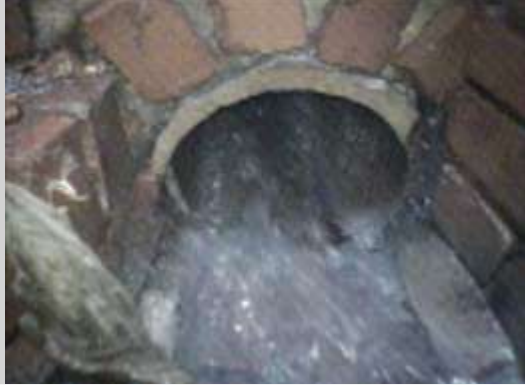
12 O'Clock Outflow

Pipe Height: **8.4** (in.) Rod and Bar (Angled)  
Pipe Material: **Clay** ☐ Pipe Lined  
Invert Depth: **13.92** (ft.) Flow Characteristics: **Fast**  
Deposits: ☒ None ☐ Mud ☐ Sludge ☐ Debris ☐ Grease  
Silt Depth: (in.) Deposits Extent:  
Infiltration: **None** Pipe Seal Cond: **Sound**

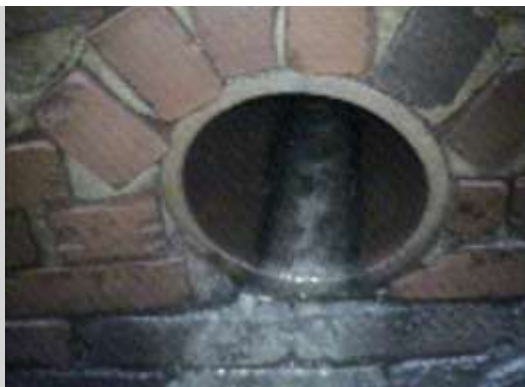
3 O'Clock Inflow

Pipe Height: **8.4** (in.) Rod and Bar (Angled)  
Pipe Material: **Clay** ☐ Pipe Lined  
Invert Depth: **12.88** (ft.) Flow Characteristics: **None**  
Deposits: ☒ None ☐ Mud ☐ Sludge ☐ Debris ☐ Grease  
Silt Depth: (in.) Deposits Extent:  
Infiltration: **None** Pipe Seal Cond: **Sound**

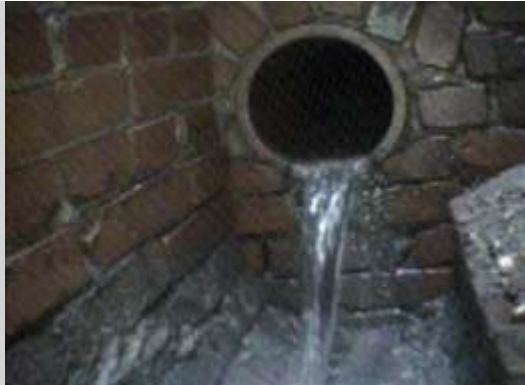
6 O'Clock Inflow

Pipe Height: **8.4** (in.) Rod and Bar (Angled)

Pipe Material: **Clay** ☐ Pipe Lined

Invert Depth: **12.88** (ft.) Flow Characteristics: **Fast**

Deposits: ☒ None ☐ Mud ☐ Sludge ☐ Debris ☐ Grease

Infiltration: **None** Pipe Seal Cond: **Sound**

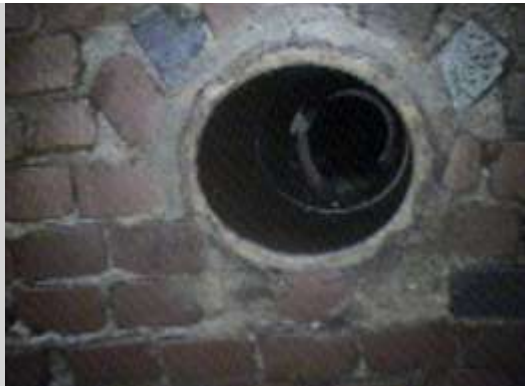
9 O'Clock Inflow

Pipe Height: **8.4** (in.) Rod and Bar (Angled)

Pipe Material: **Clay** ☐ Pipe Lined

Invert Depth: **11.28** (ft.) Flow Characteristics: **Fast**

Deposits: ☒ None ☐ Mud ☐ Sludge ☐ Debris ☐ Grease

Infiltration: **None** Pipe Seal Cond: **Sound**

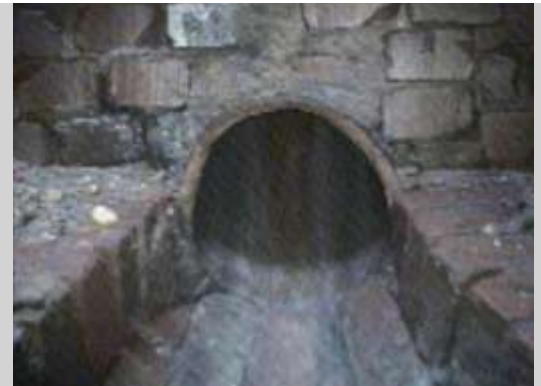
Drop In @ 9 O'Clock

Drop: **Outside** Rod and Bar

Angled: **Yes** Reading: **12.48** (ft.)

Inv Depth: **13.48** (ft.)

Drop Condition: **Open**
